**Water Resources Department**

December 19, 2016

**Re: Morgan Lake (M-64) – Inspection Summary**

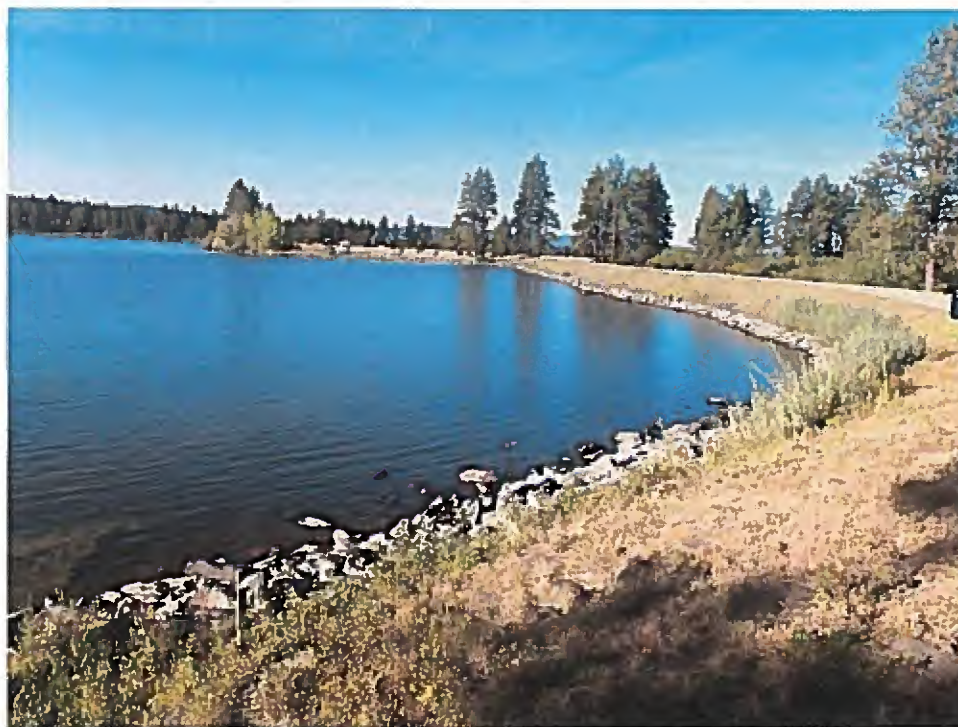
**Upstream face indicating current and minimum freeboard has been adequate**

The reservoir level was 6.6 feet below the dam crest when inspected. Minimum freeboard was 4.2 feet, which is adequate. The pine tree near the toe of the dam has been removed and the dam has a well maintained cover of grass. The grass cover on the dam effectively reduces surface erosion and provides very little cover for burrowing animals. However, there was minor vegetation on the upstream face of the dam. Although this vegetation has not yet become a dam safety issue, regular clearing will prevent these dam safety issues from becoming more serious in the near future.

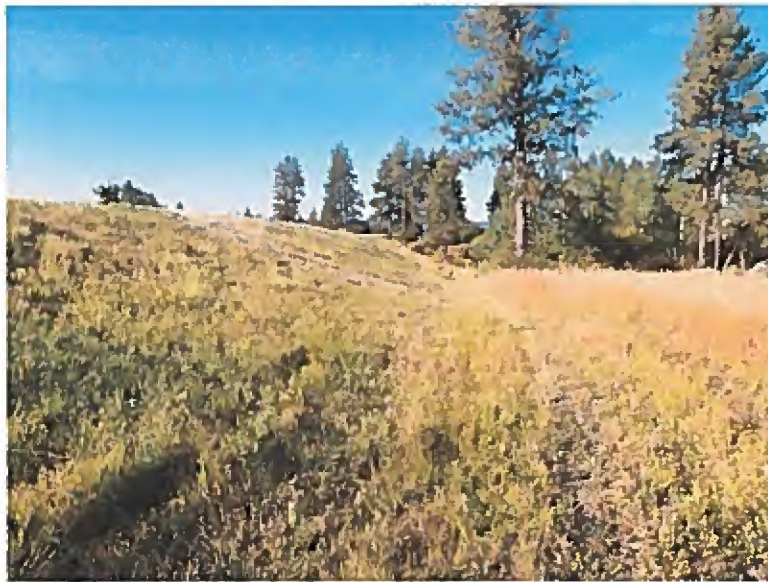
**Well maintained grass cover on the downstream face of the dam**

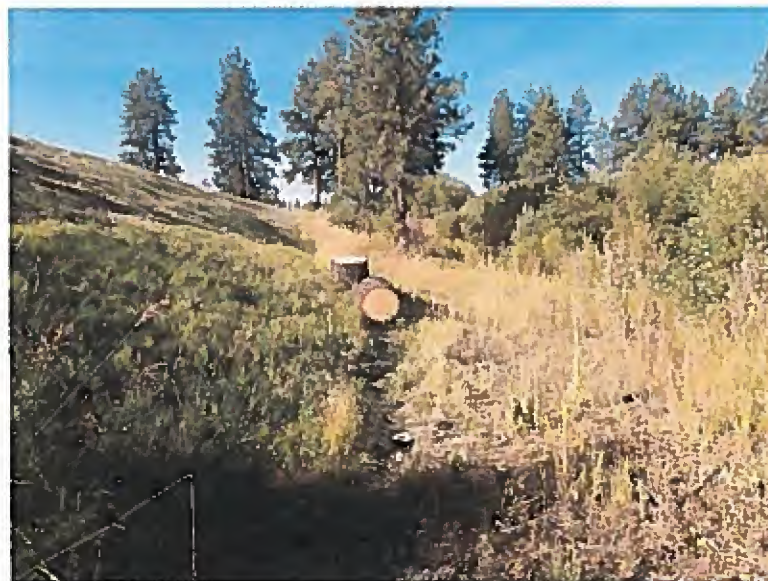
**Large pine recently removed from the toe of the dam**

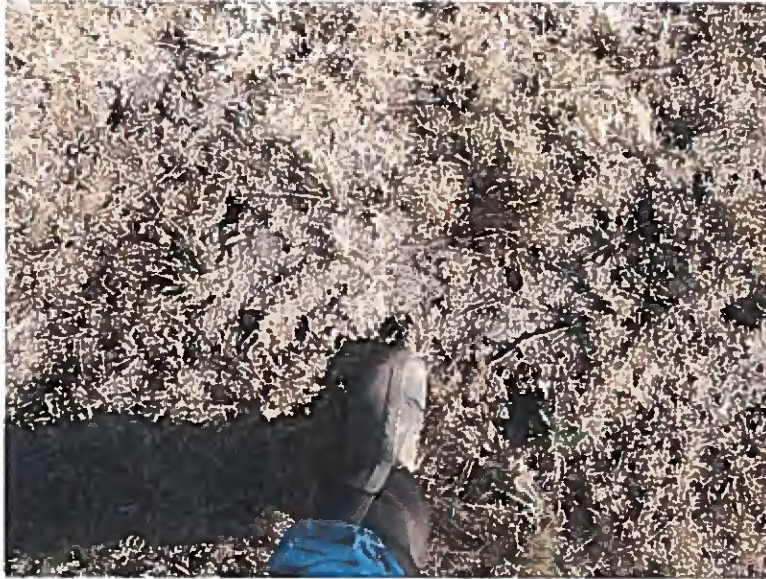
**Animal activity on the upstream face of the dam**

In addition, there was animal activity observed on both the upstream and downstream slope of the dam on both the main and auxiliary dams. Burrowing animals create holes in the dam that can compromise the structural integrity of the dam or increase settlement of the embankment. When the embankment settles, low spots can be left on the crest of the dam which reduce the amount of freeboard and increase the potential for overtopping of the dam. In the case of Morgan Lake dam, the current animal activity is from small burrowing animals and is not causing a serious dam safety issue at this time. However, the activity should be monitored. In 2001, burrowing marmots triggered a leak in the auxiliary dam, so if these animals return, action will be needed.

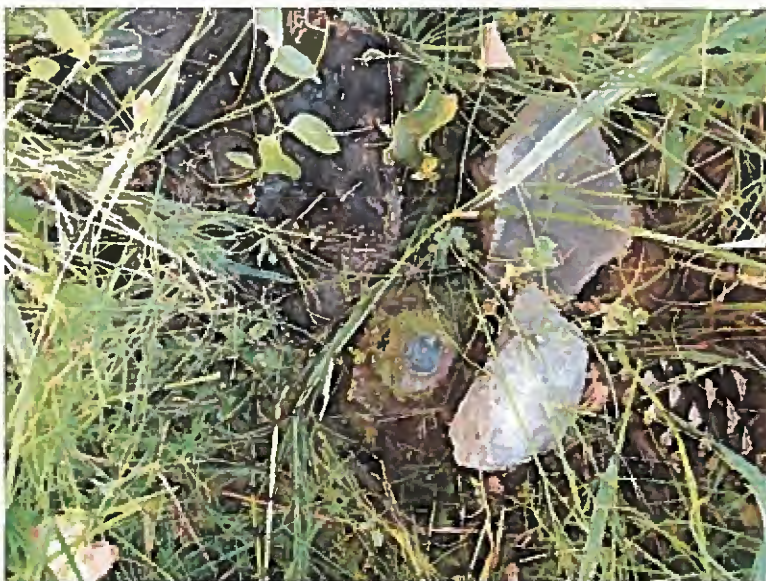
**Location of low level conduit controls partially buried**

The upstream end of the low level outlet conduit is submerged and the downstream end is buried. As a result, we were unable to inspect the condition of the outlet conduit. Very little is known regarding the condition of the conduit. It is possible that the reservoir side is open, so that the conduit through the dam is pressurized. Additional investigation of this pipe has been warranted for some time, as prior attempts could not locate the inlet in the lake. The outlet is currently not operable. Consequently, there is no way to drain the reservoir in the event of an emergency. A properly working outlet conduit is a key safety feature of a dam.

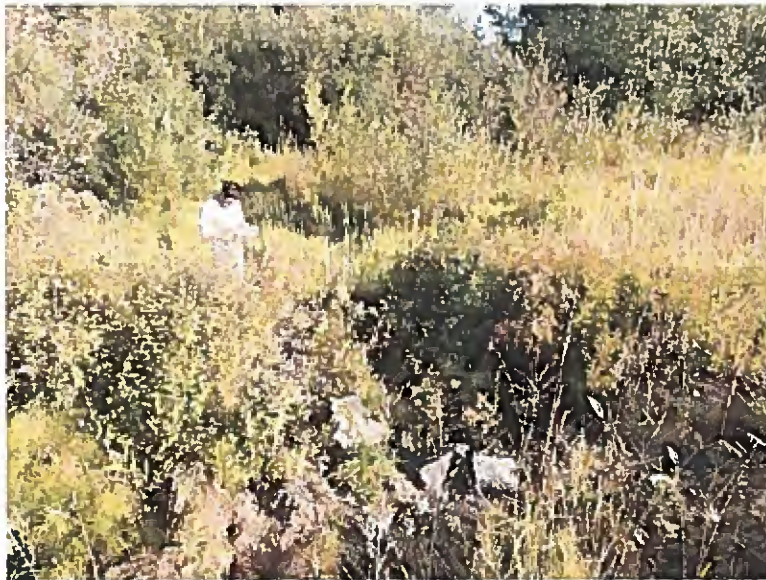
**Area of seepage off of the dam near the toe**

There has been no sign of seepage on the auxiliary dam since the repairs in 2011. However, there is an area of minor seepage just off of the main dam near the toe at the location of the buried outlet pipe. The source of the seepage is either from underneath the dam or from a leak in the buried outlet conduit. We are unable to determine the source at this time because the conduit is buried.

Seepage due to a leak in the outlet conduit represents a much more serious dam safety concern than seepage that occurs underneath the dam. Seepage related to the conduit can occur either through the conduit, if it has deteriorated, or along the outside of the conduit. In either case, seepage can lead to internal erosion which can eventually lead to catastrophic dam failure if left unchecked.

1. Monitor the downstream face of the dam for any change in seepage.
2. Begin planning for construction of a diversion berm to divert potential breach flow towards Sheep Creek and away from LaGrande as per prior recommendations and on site discussions with the City and Howard Perry from Anderson Perry Consulting.
3. Clear the minor amount of vegetation on the upstream face of the dam

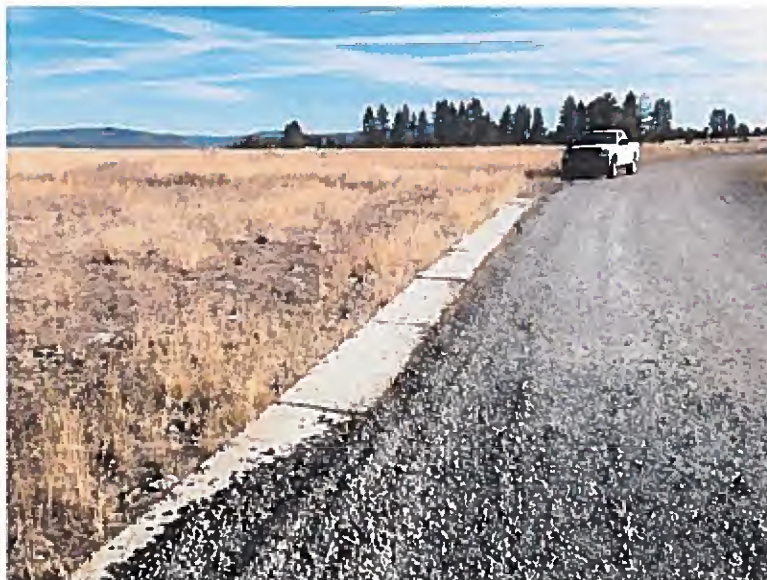
**Concrete control section of the emergency spillway**

This concrete control should remain the highest point in the spillway. The gravel road is to be graded to this level. As long as it is maintained this way, there should be no risk of overtopping in any potential flood event.
